Subj: ADDITIONAL COMMENTS ON COLE DAMAGE CONTROL AND
ENGINEERING SYSTEMS

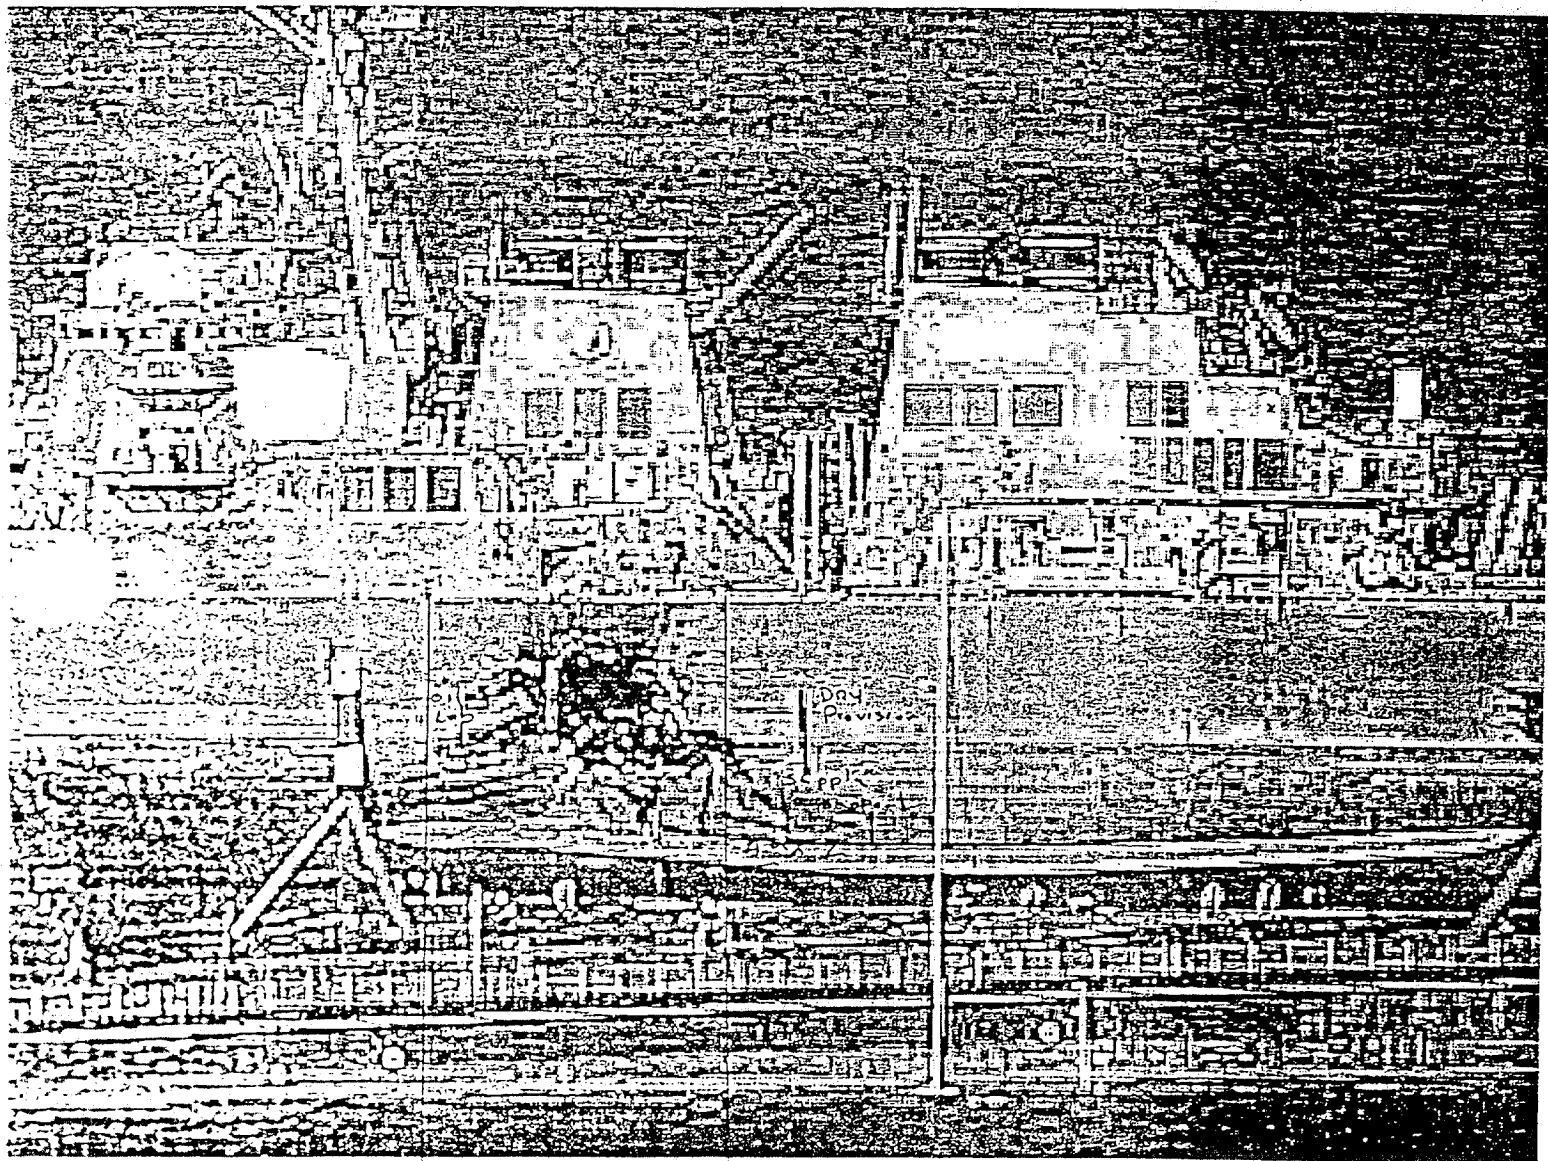
USS COLE MACHINERY LAYOUT

2 Feet of
Flooding

Fresh Water tanks 2 & 4 cracked

Blast hit at
Fr 220

4 Feet of
Flooding
